# Lichens and other lithobionts on the carbonate rock surfaces of the heritage site of the tomb of Lazarus (Palestinian territories): diversity, biodeterioration, and control issues in a semi-arid environment

**Purpose** Investigations on the lithobiontic colonization of the stone cultural heritage in (semi-)arid regions are needed to address conservation strategies. In this work, lithobiontic communities were examined on the carbonate rock surfaces of the heritage site of the Tomb of Lazarus. We aimed to evaluate their distribution and interaction with the lithic substrate, together with the efficacy of biocidal treatments for their control.

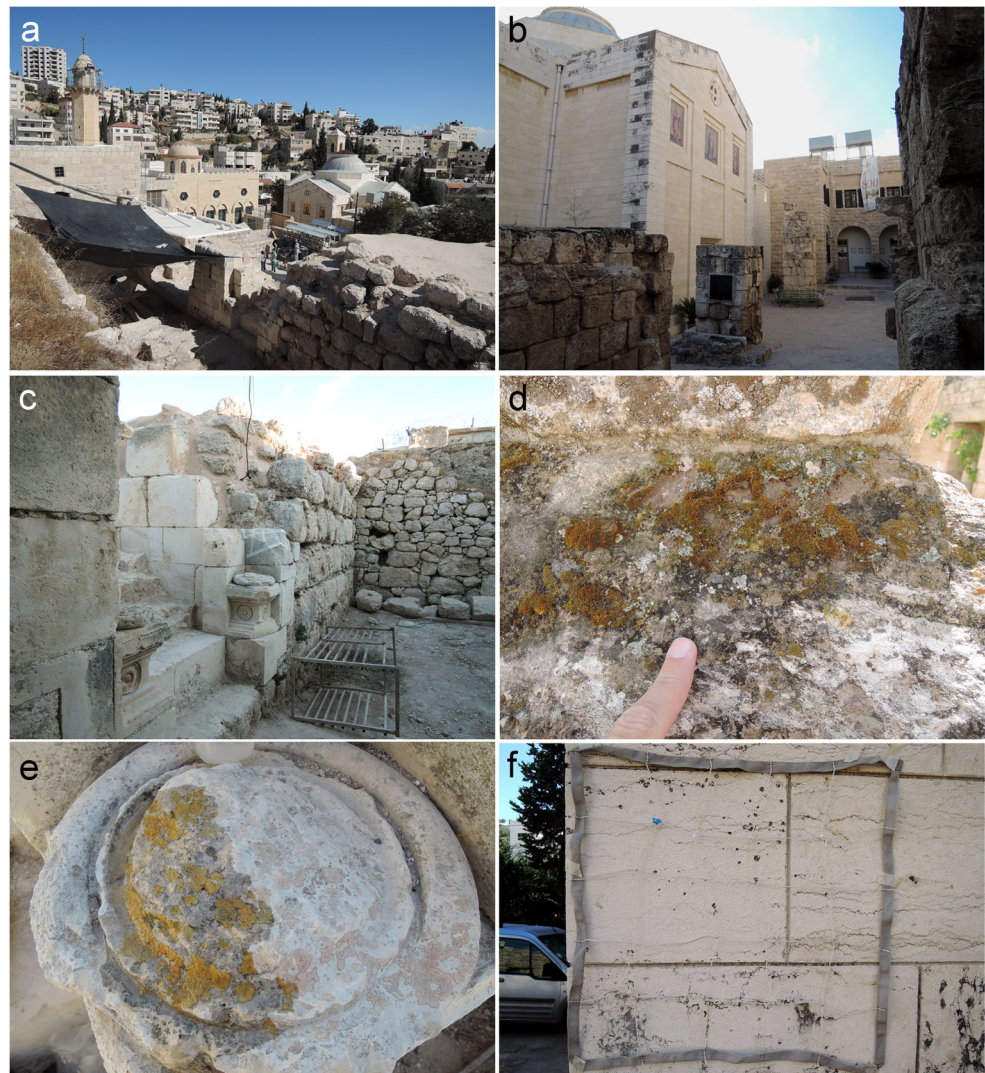
**Fig. 1** The site of the Tomb of Lazarus. **a** Walls of the crusaders' monastery in the foreground, and view of Mosque of al-Uzair (left) and the modern Church of Saint Lazarus (right) in the background. **b** Lower "Plaza," with the pillars of the Byzantine and Crusaders' antique churches in the foreground, and the façade of the modern church in the left background. **c** Walls of the Crusaders' Monastery, with carved capitals in the foreground. **d** Lithobiontic community including chlorolichens, bryophytes, and a black cyanobacterial biofilm on blocks of the pillars of the antique church. **e** Upper surface of a carved capital of the Crusaders' Monastery, covered by lichens (mostly orange thalli of *Variospora aurantia*) partially hidden by dust deposits, but made visible by wetting their thalli (left side). **f** Black fungi, in part overgrowing chlorolichens, on the façade of the modern church (the 50 × 50 cm square grid used for relevés is visible on the vertical surface)

The field survey and subsequent microscopical observations indicated chlorolichens, bryophytes, and black biofilms of different compositions as biodeteriogens responsible for phenomena of esthetic damage in the site of the Tomb of Lazarus (Figs. 1d–f and 2). On the carbonate rock blocks of the antique churches and the monastery, chlorolichens were the dominant component in terms of both frequency per plot (median > 90% of quadrats) and surface cover (median > 20%). Black biofilms and, subordinately, bryophytes were common on the pillars of the antique churches, on which they were responsible for remarkable covers (av. > 10%), while their presence was rather negligible on the monastery walls. On the walls of the modern church, chlorolichens and black biofilms displayed high frequency values (av. > 30%), but remarkable covers only sparsely occurred (median < 5%) and were mostly located in the upper parts of the façade (Fig. 1b), not accessed for the relevés.

adapted to the more xeric conditions of the walls of the monastery, located in the wind-exposed upper part of the site, where rock surfaces are widely covered by dust (Fig. 1e). It is worth noting that nitrophytic lichen species, tolerant of (and even favored by) nitrogen deposition, including ammonia pollution, prevail throughout the site (9 out of the 17 species have maximum eutrophication index  $\geq 4$ ; Table 1), as generally reported for monuments in urban (Aptroot and James 2002; Seaward 2015) and agricultural areas (Nascimbene and Salvadori 2008; Sohrabi et al. 2017). Both the dominant species *Variospora aurantia* and *Verrucaria ochrostoma* are nitrophytic species (Nimis 2016). The former, displaying highest frequency and cover values on the monastery walls, was previously reported as highly tolerant to harsh conditions of sun irradiation, aridity, and air pollution (Garty 1999). Only the nitrophytic *Calogaya pusilla* determined remarkable lichen covers on the walls of the modern church, made of the same lithotype, but characterized by a poor colonization with respect to the surrounding antique surfaces. Abiotic and biotic weathering forces may have not so far modified the scarce intrinsic bioreceptivity of the strong and durable Jerusalem stone (Ghadban and Ashhab 2011) towards a remarkable secondary (i.e., weathering induced) bioreceptivity (Guillitte 1995; Miller et al. 2009). A prominent occurrence of species of *Caloplaca s.l.* (6 out of the 17 species in the investigated site) also characterized carbonate surfaces of the Pasargadae UNESCO world heritage site (Iran), where frequent events of windstorms contribute to nitrogen and dust deposition (Sohrabi et al. 2017). In such species, adapted to alkaline substrates (Ariño et al. 1995), a role of dust deposits on the thalline surface in protecting photobionts by excessive sun irradiation, together with biosynthesized calcium oxalate and parietin deposits (Smith et al. 2009) may be worth to be considered.

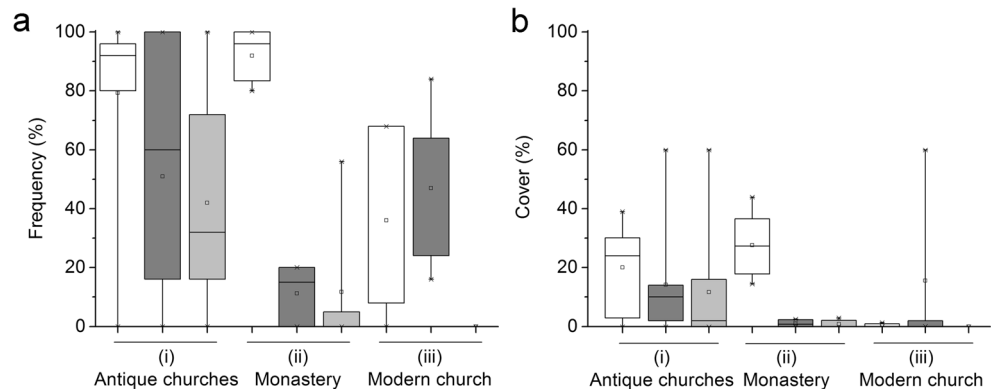
**Fig. 2** Frequency (av. % per plot, **a**) and cover (% **b**) of lithobionts (lichens, white columns; black biofilm, dark gray columns; bryophytes, light gray columns) on the investigated architectural elements in the site of the Tomb of Lazarus. Maximum (upper whisker), 75th percentile (top box), mean (square), median (transversal line), 25th percentile (bottom box), minimum (lower whisker)
